Operating Experience Summary

May 26 — June 16, 2000

Summary 2000-11

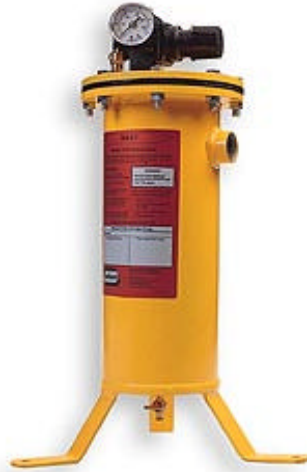
Figure 2-1. Bullard Air-Line Filter Model 41AF

On May 12, 2000, at the West Valley Demonstration Project, operators discovered a potential defect with certain Series 41 AF Bullard air-line filter cartridges. Operators noticed that Bullard filters labeled SO#80929 rattled when shaken, and when they opened one to investigate the source of the noise, they discovered that the uppermost filter and wire mesh screen had been creased underneath the plastic top cover. Operators also noticed that the contents of the filter appeared to be mixed together rather than separated in distinct layers. Facility management contacted the manufacturer and removed all Bullard filters labeled SO#80929 until they could determine whether the damaged filters could affect air quality. Defective air filters can render personnel vulnerable to harmful air quality. (ORPS Report OH-WV-WVNS-CF-2000-0004)

The manufacturer has accepted responsibility for the problem and has stated that the defect stems from incorrect packing of the top carded cotton filter. Figure 2-1 shows Filter Model 41AF, and Figures 2-2 and 2-3 show the filter cartridge and the inside of the filter housing. The manufacturer also stated that breathing air quality would not be

compromised as a result of this defect but agreed to replace the defective filters. The manufacturer sent a letter to the West Valley Demonstration Project acknowledging the problem filters and stated that they have taken corrective action to eliminate future occurrences. For further information about the defective filters, contact Jay Parker, the manufacturer's representative, at 1-800-227-0423. For additional information regarding the West Valley Demonstration Project call Carol Schmeidler at 716-942-2086. There were no injuries associated with this event.

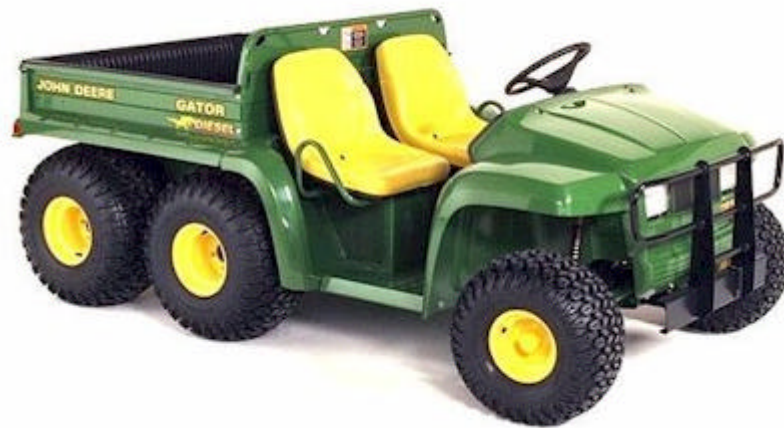
Figure 4-1. Gator Utility Vehicle

In the second event, investigators learned that a laborer trying to drive the Gator that morning found the accelerator cable disconnected. Instead of logging the vehicle out of service for repair by qualified and trained maintenance personnel, the laborer reconnected the cable. A teamster driving the Gator delivering a trackhoe operator (passenger on the Gator) hit a dirt clump with the right front wheel of the vehicle while approximately eighteen inches up the dirt ramp where the trackhoe was located. The Gator rolled onto the driver side, pinning the driver's left foot under the gator. The trackhoe operator unbuckled his seatbelt, fell onto the teamster, then on the ground outside the Gator, and righted the gator to free the teamster's foot. The teamster was conscious, complained that the gas pedal had stuck on the gator, and indicated that his left ankle was hurt. The operator tried to radio his superintendent, but got no reply because the radio was in a reception dead zone. Under instructions not to move an injured worker, the trackhoe operator ran about 100 feet down the embankment to the superintendent and a subcontractor aid station to get help. Two laborers went up the hill to the accident scene where the teamster lay face down on the ground. One of the laborers drove the Gator to the entrance of the Quarry Area to await an ambulance and direct emergency vehicles to the accident scene. The subcontractor used heavy equipment to prepare the excavation area for vehicle access to evacuate the injured teamster.

- Equipment needing repair (the Gator's disconnected accelerator cable) should be tagged, taken out of service, and repaired by qualified and trained personnel. A supervisor was not notified that the Gator needed repair earlier that day.
- The subcontractor is unable to provide documentation that all operators of the Gator were familiar with the vehicle operator's manual.
- The route of travel taken by the teamster to deliver the trackhoe operator was inappropriate and unnecessary. A gator was not needed in the Quarry Area.
- Use of the Gator to flag down and direct the emergency response unit vehicles compromised the accident scene.
- The subcontractor superintendent who escorted the injured employee to the hospital emergency room failed to order a post accident drug screening.
- The injured employee's statement was not taken until 6 days after the event.
